Clinical-Medical Image

Hot Spot Sign: An Indicator of Thoracic Central Venous Obstruction

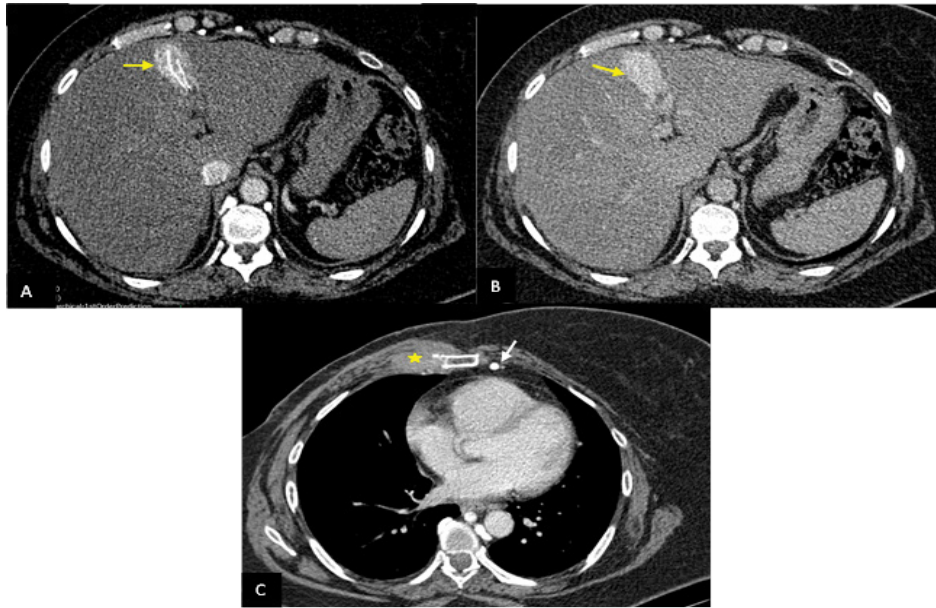
Figure 1: Axial views of an abdominal enhanced CT scan in arterial (A) and portal (B) phases, showing the hot spot sign as a well-defined focal enhanced area of segment IV of the liver (yellow arrows). The thoracic enhanced CT scan (Image C) shows a mass in mastectomy zone (yellow star) invading the right internal mammal artery and vein (compared to contralateral vessels shown with white arrows).

The hot spot sign is a radiological sign found in a contrasted CT-scan or technetium 99 m sulfur colloid scans. It was first described in 1983 by Ishikawa. It corresponds to a focal well shaped enhanced area in arterial or portal phase within the quadrate lobe of the liver also known as the IVb segment of the Bismuth-Couinaud classification system. It was first diagnosed in a superior vena cava syndrome and is caused by portosystemic venous shunt between the superior vena cava (SVC) and portal vein, mostly due to the obstruction of the SVC. Thus, it reflects an increased blood flow due to the shunting. It is an indicator of a thoracic central venous obstruction, as seen in the images above, showing a hot spot sign caused by the right internal mammal vein obstruction secondary to the recurrence of a breast cancer invading the internal mammal vessels (Figure 1).
